STEAM TURBINE INLET PIPING- A CASE STUDY

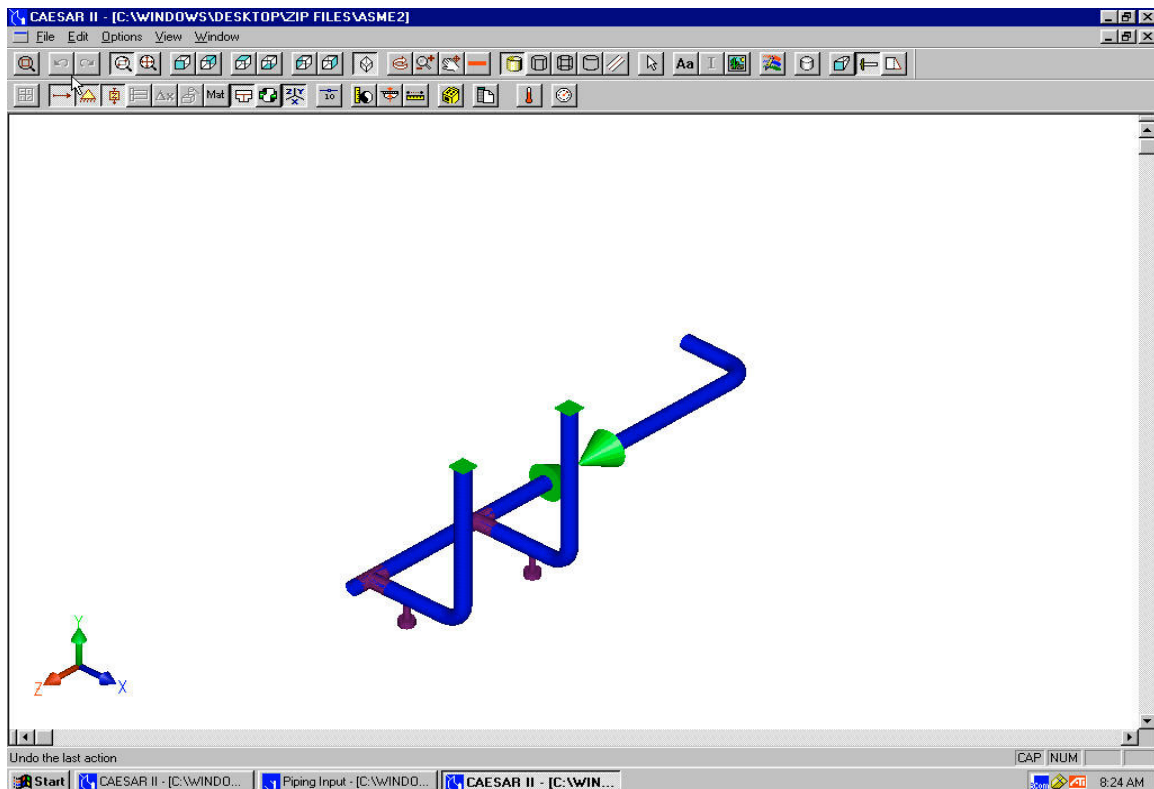
The whole INCIDENT was forgotten, considering it as it to be within nozzle alignment tolerances. This misalignment however aggravated in the successive shutdowns. In addition to that turbine in-board bearings and compressor to turbine coupling displayed extra-ordinary wear.

This situation was discussed in the higher quarters, and it was unanimously decided to get the piping of the turbine & compressor re-stress analyzed. Below is the previous configuration of the entire inlet piping – Steam Side

Piping Isometrics and operating conditions were sent to an offshore Stress Analysis company. The experts gave the opinion that piping has been fatigued. The cause of fatigue was higher through put than the deigned value. The throughput was increased during he BMR (Balancing, Modernizing, Revamp). The results of the fatigue are permanent, plastic de-shaping. The situation could get worse, so two recommendations should be followed on urgent basis. Firstly, the routing should be changed as below.

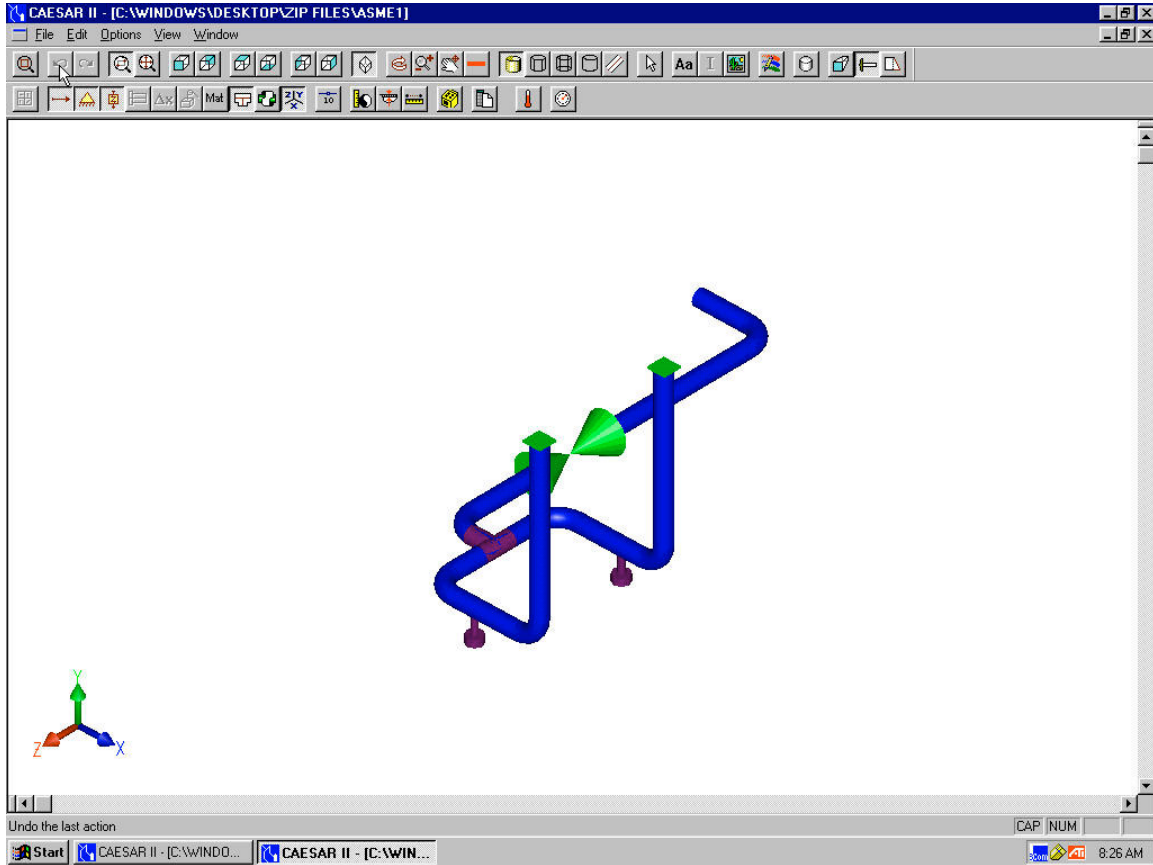
Firstly as can be seen that entire Z-Z AND X-X (Transverse and Lateral), thermal growth of turbine, has been compensated in the piping configuration, which previously was not as efficiently done.

Secondly the material should be changed to Low-Chrome alloy.

Secondly, the new material recommended, has better severe temperature endurance properties, thus preventing it to be plastic at ultra-high temperatures and thus give better long-term trouble-free service.

This 8" Sch XXS, pipe has also special fabrication requirements, 100% Radiography, and Post Weld heat treatment (Stress Relief). Secondly, in order that welding contraction stresses, for such heavy thickness, should not pull the finished piping out of alignment, one spool should be Bolt tightened along with the turbine, and insulating joint to be used for such flanges so that welding currents should not deteriorate lube-oil of he turbine in the console.
